July 20, 2019

SUBJECT: Discussion of Bluff Stability at 772 Neptune Avenue, Encinitas, CA

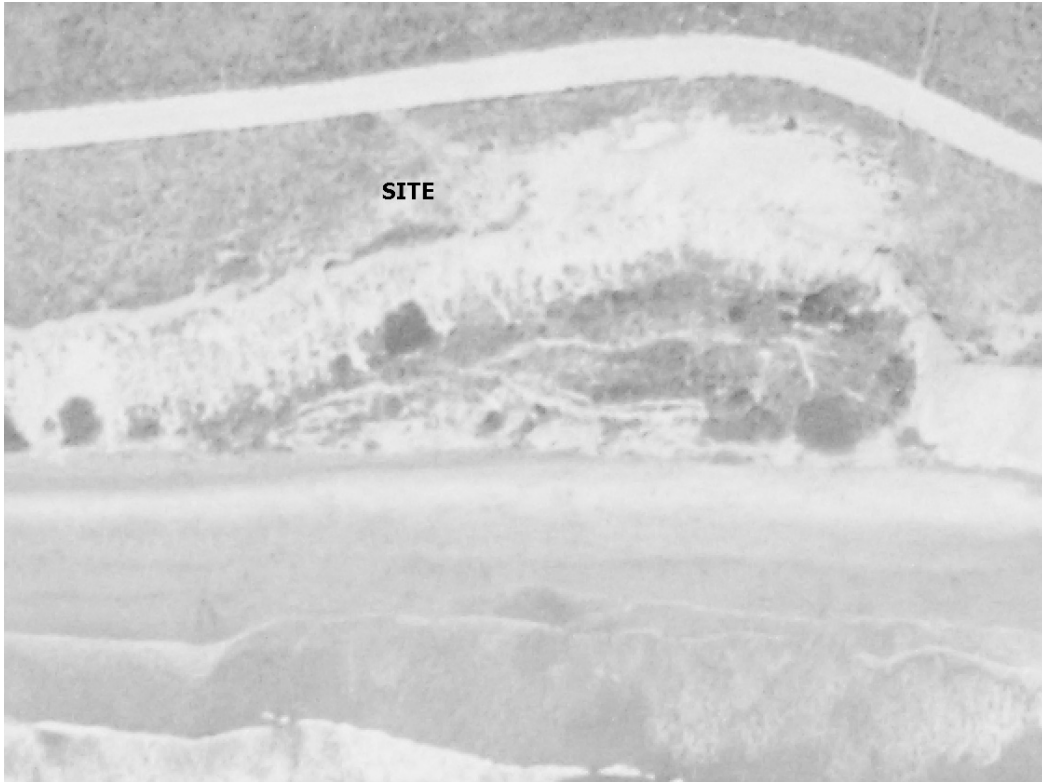
Figure 1. Subject site with landslide fronting the bluff in 1932.

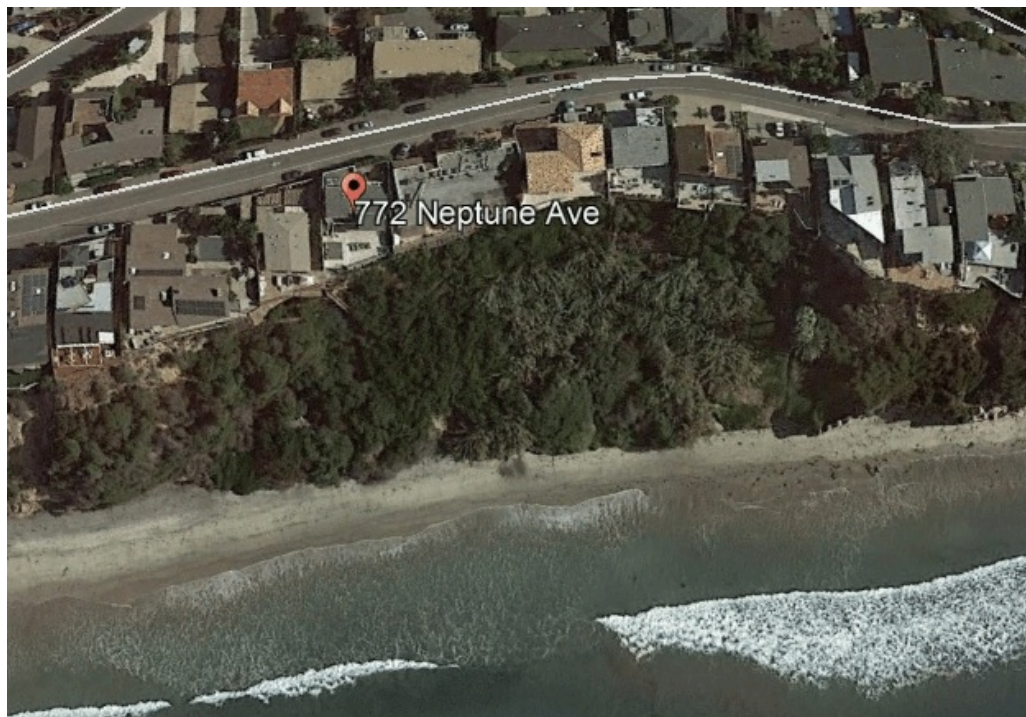
Figure 2. Site and landslide in December 2017 from Google Earth.

In other sections of bluff in Encinitas, where there is no landslide at the bluff toe, the typical failure mechanism is for the lower geologic unit to fail in a block that triggers the failure of the upper terrace deposits. At this site that process will not occur until the toe of the landslide approaches the upper portion of the bluff below the patio. This is a distance of about 150 feet. The US Army Corps of Engineers has documented a historical retreat rate in the site area (not at the subject site in particular) of 0.4 feet per year. At this rate, for the landslide toe to reach the site it would take about 375 years. Comparing Figure 1 and Figure 2, photographs taken about 85 years apart, it is difficult to see any movement of the toe of the landslide. Using the 0.4 ft per year rate you would expect to see perhaps 34 feet of erosion. It is also interesting to note on the Assessor Parcel Map (APN) the top of the upper bluff is denoted and shows that the distance from the north property line to Neptune Avenue ROW is about 93 feet. That distance measured today is almost the same (about 91 feet), which shows that the retreat of the upper bluff has been very small.
